# **Navajo Abandoned Uranium Mine**

## **Site Screen Report**

### **Cam061 AUM Site**

**January 2011**

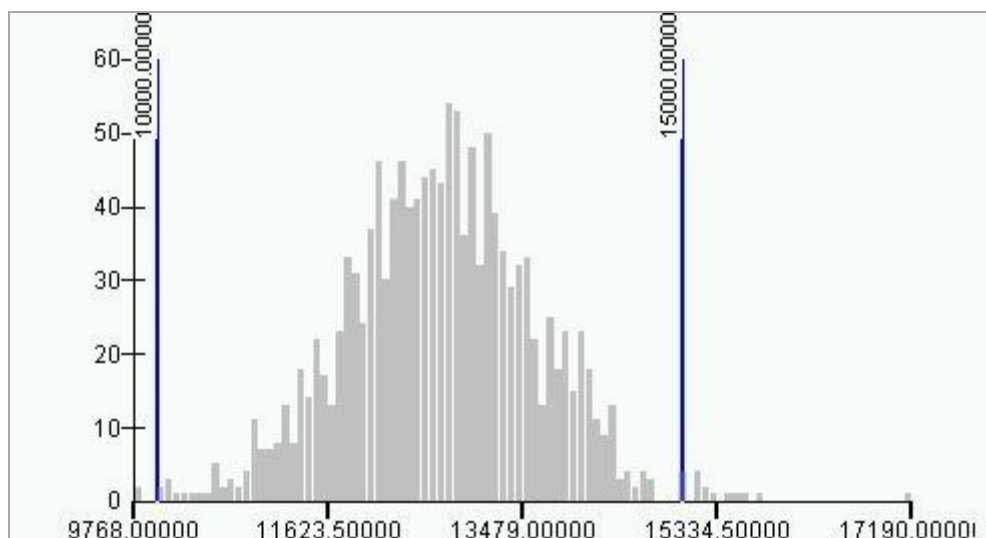
The following chart and statistics were generated by ESRI ArcGIS 9.3.1, and show the general distribution of the site gamma radiation measurements. The horizontal X axis represents the gamma radiation reading levels in cpm (lowest levels to the left). The vertical Y axis represents the frequency of each gamma radiation level.

Count:	1352
Minimum:	9768.00000
Maximum:	17190.00000
Sum:	17177366.00000
Mean:	12705.15237
Median:	12716.50000
Standard Deviation:	906.09844

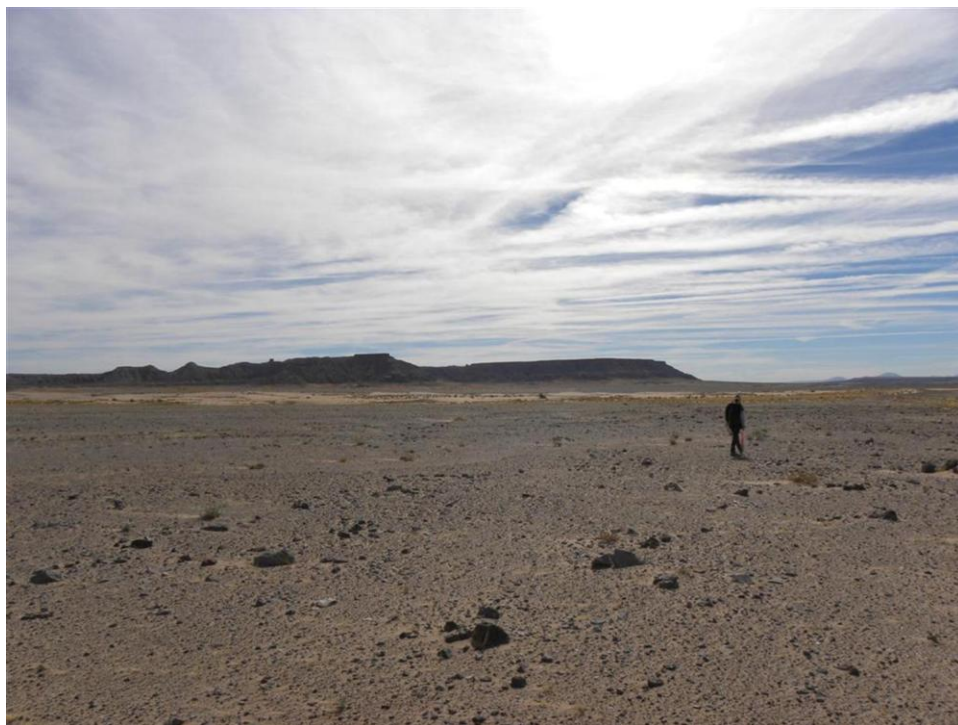
Photo 1. Cam061 mine site

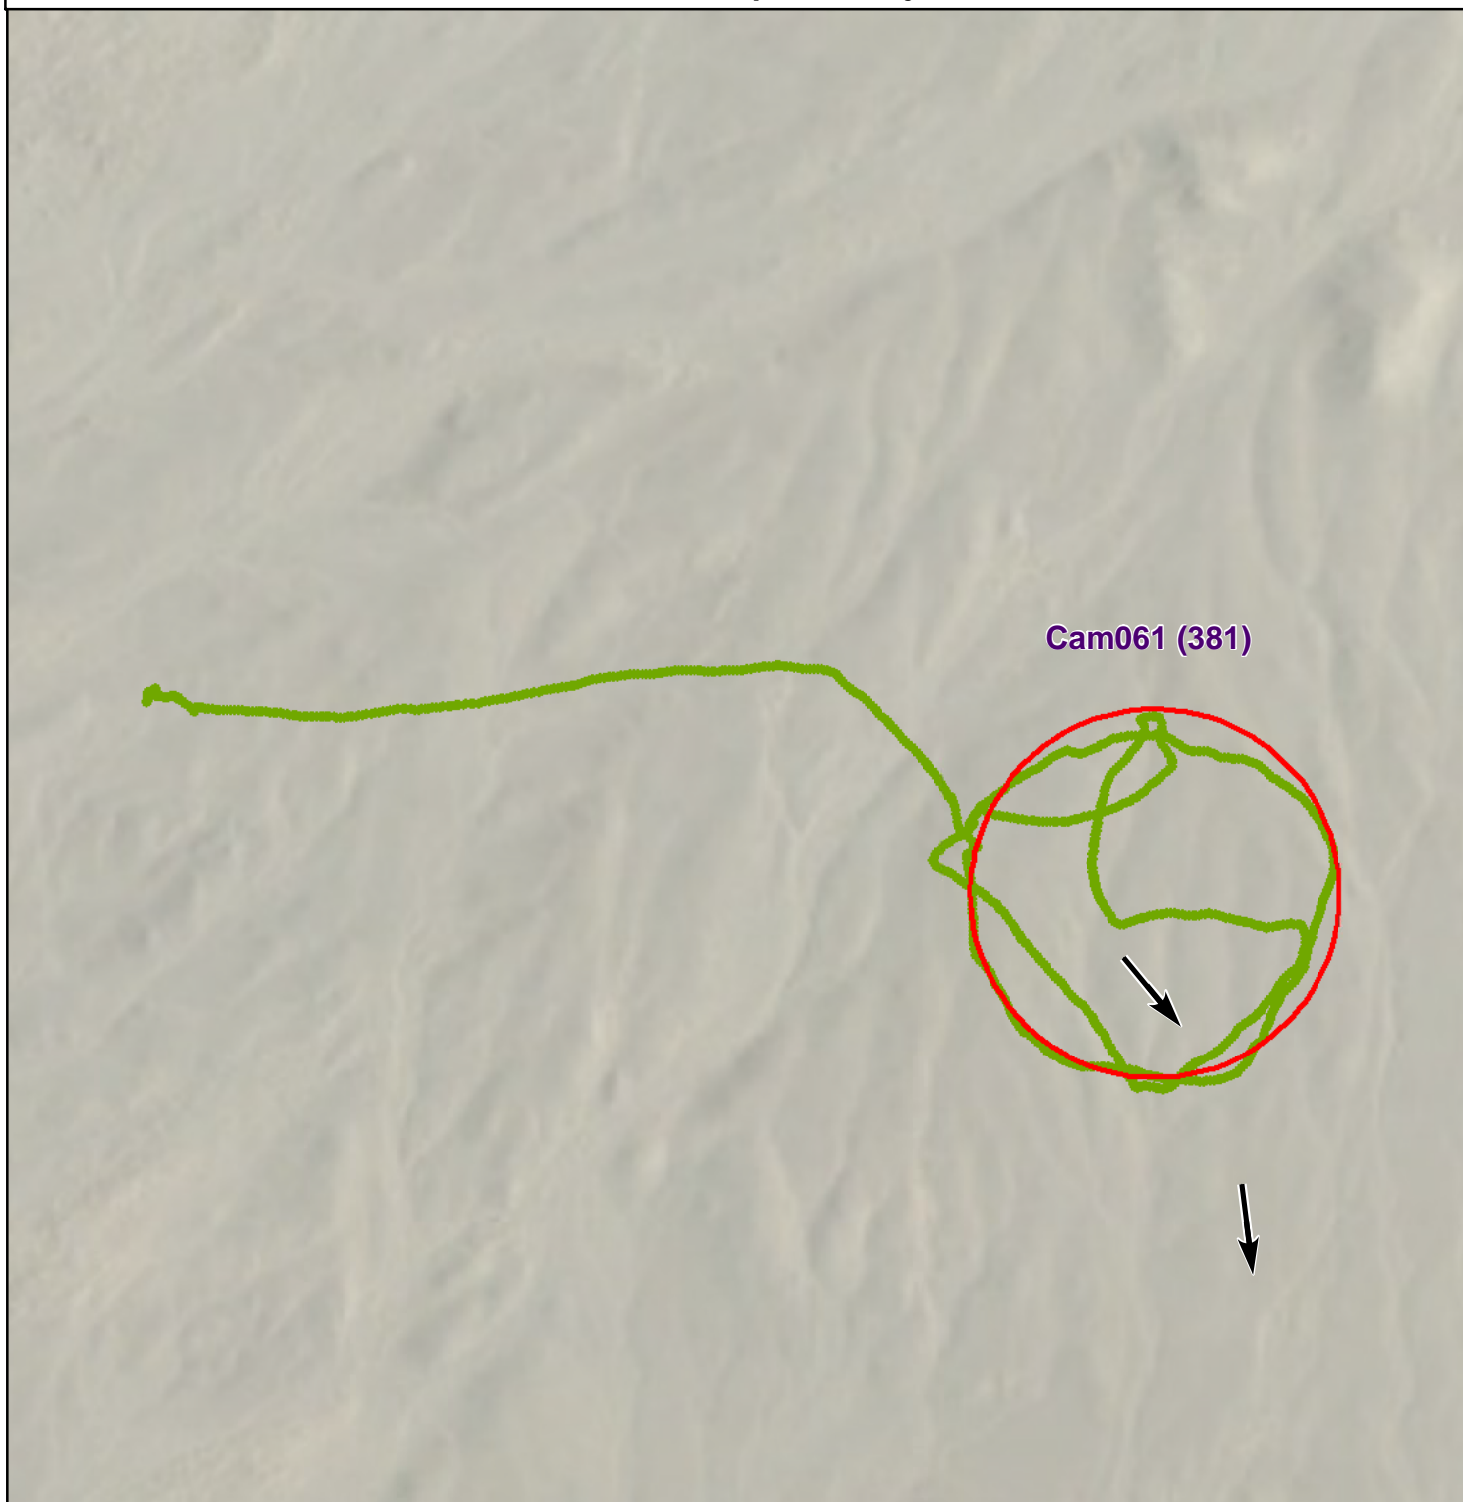
**Figure 1 - Gamma Radiation Measurements, Above Two Times  
Cam061 (381)  
Coalmine Mesa Chapter, Navajo Nation**

Gamma survey conducted 11/2010  
Measured as counts per minute (cpm)

Average background 12,457 cpm

A total of 1,352 gamma radiation measurements were collected from the mine site, ranging from 9,768 cpm to 17,190 cpm. The measurements are represented in Figures 1 and 2.

No

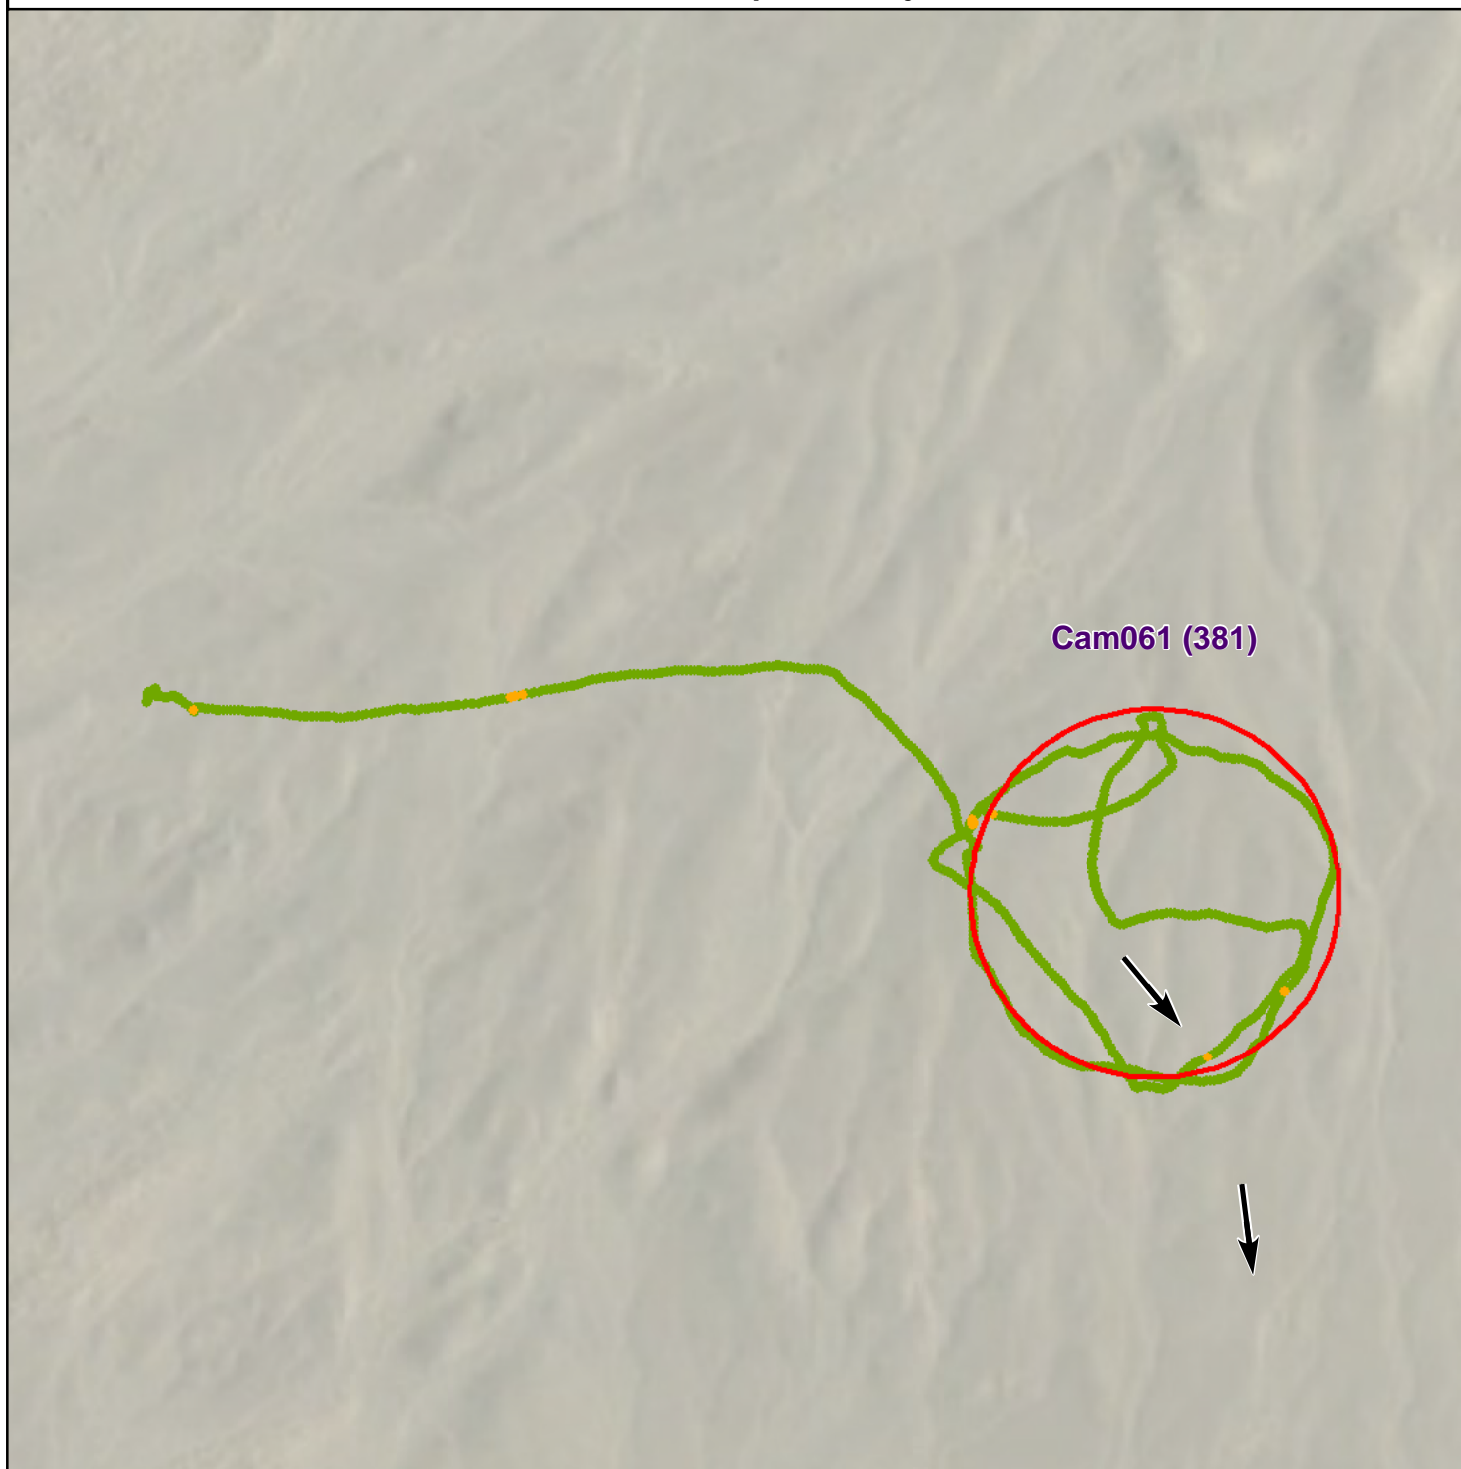
**Figure 2 - Gamma Radiation Measurements**  
**Cam061 (381)**  
**Coalmine Mesa Chapter, Navajo Nation**

**Gamma survey conducted 11/2010**  
**Measured as counts per minute (cpm)**

**Average background 12,457 cpm**
